# Botnar

*Frumathugun og staða bráðavarna*

Jón Haukur Steingrímsson

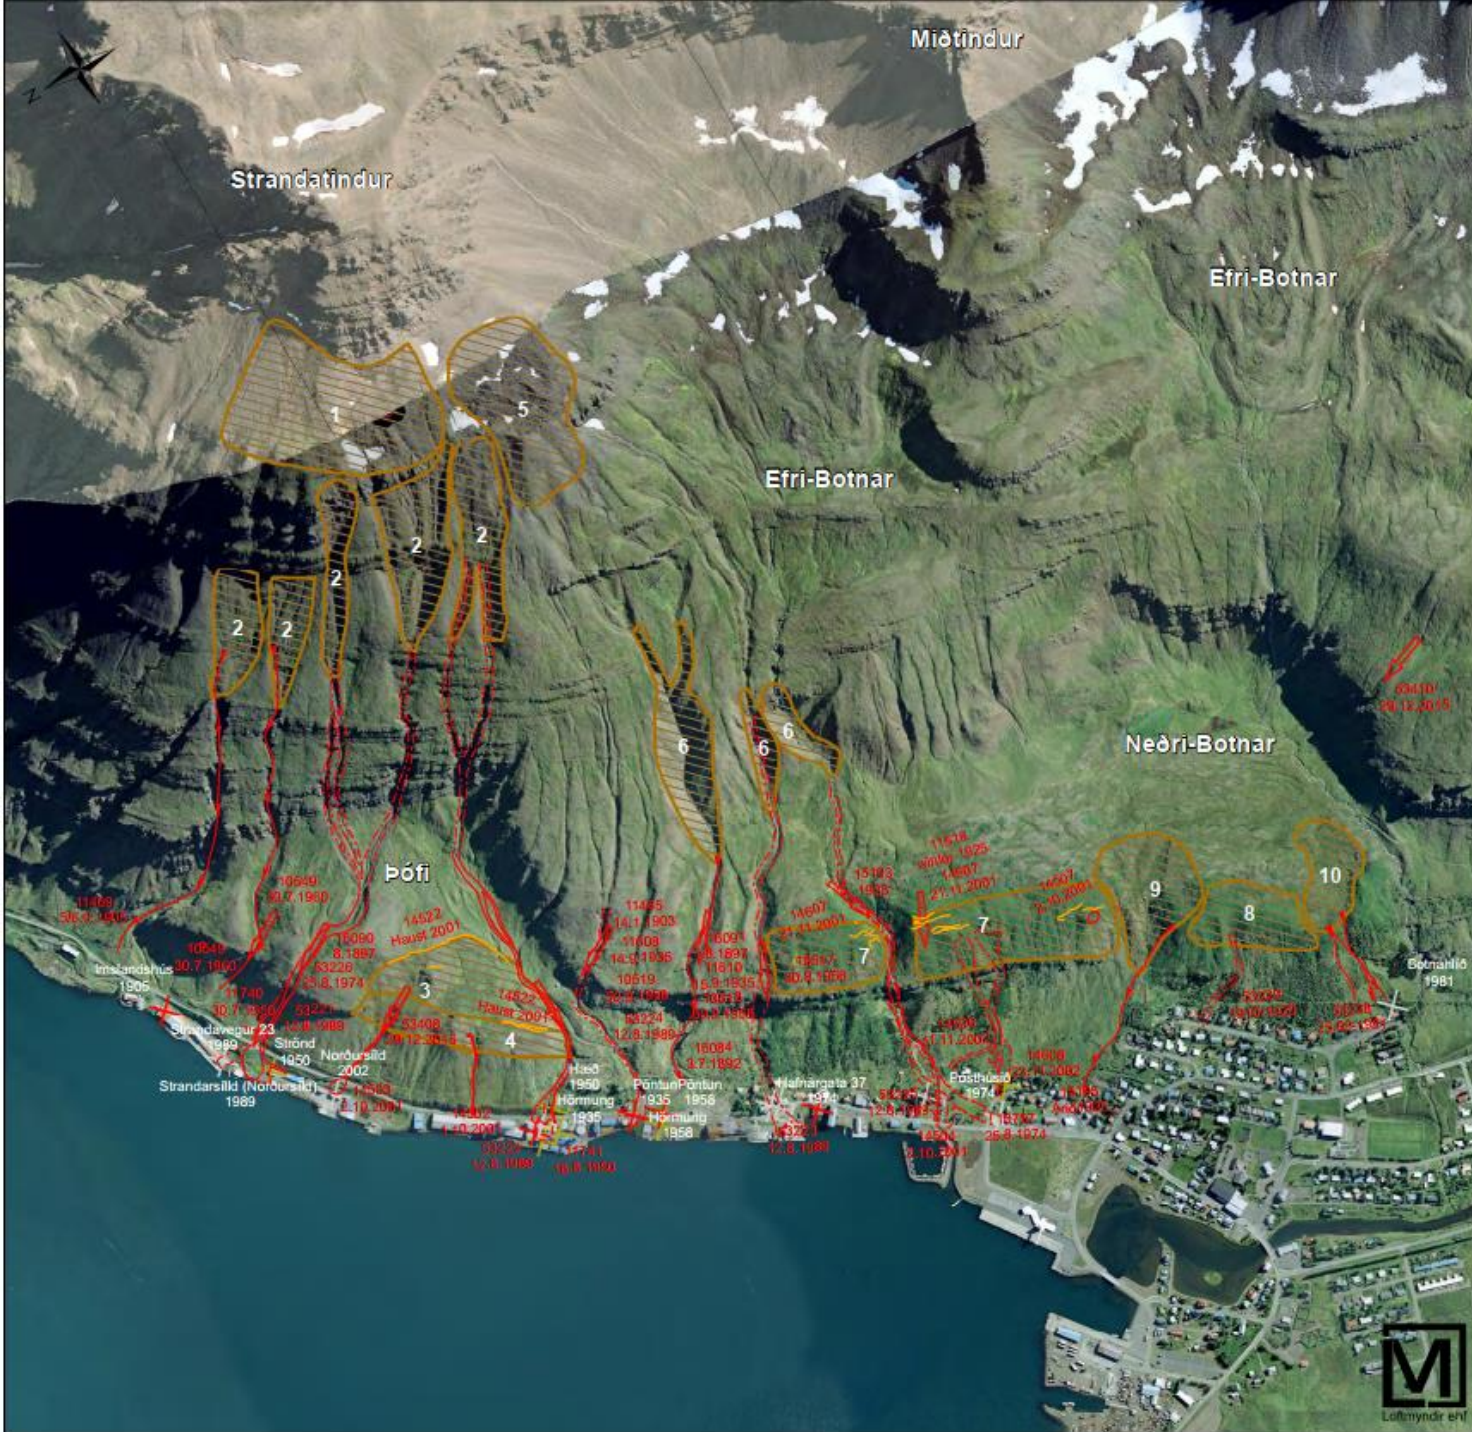
**Map 2:**  
**Landslide inventory**  
**Historical landslides southeast of Fjarðará River**

Potential source areas for landslides

Landslide outline, GPS measured
-

Landslide location and direction

House destroyed

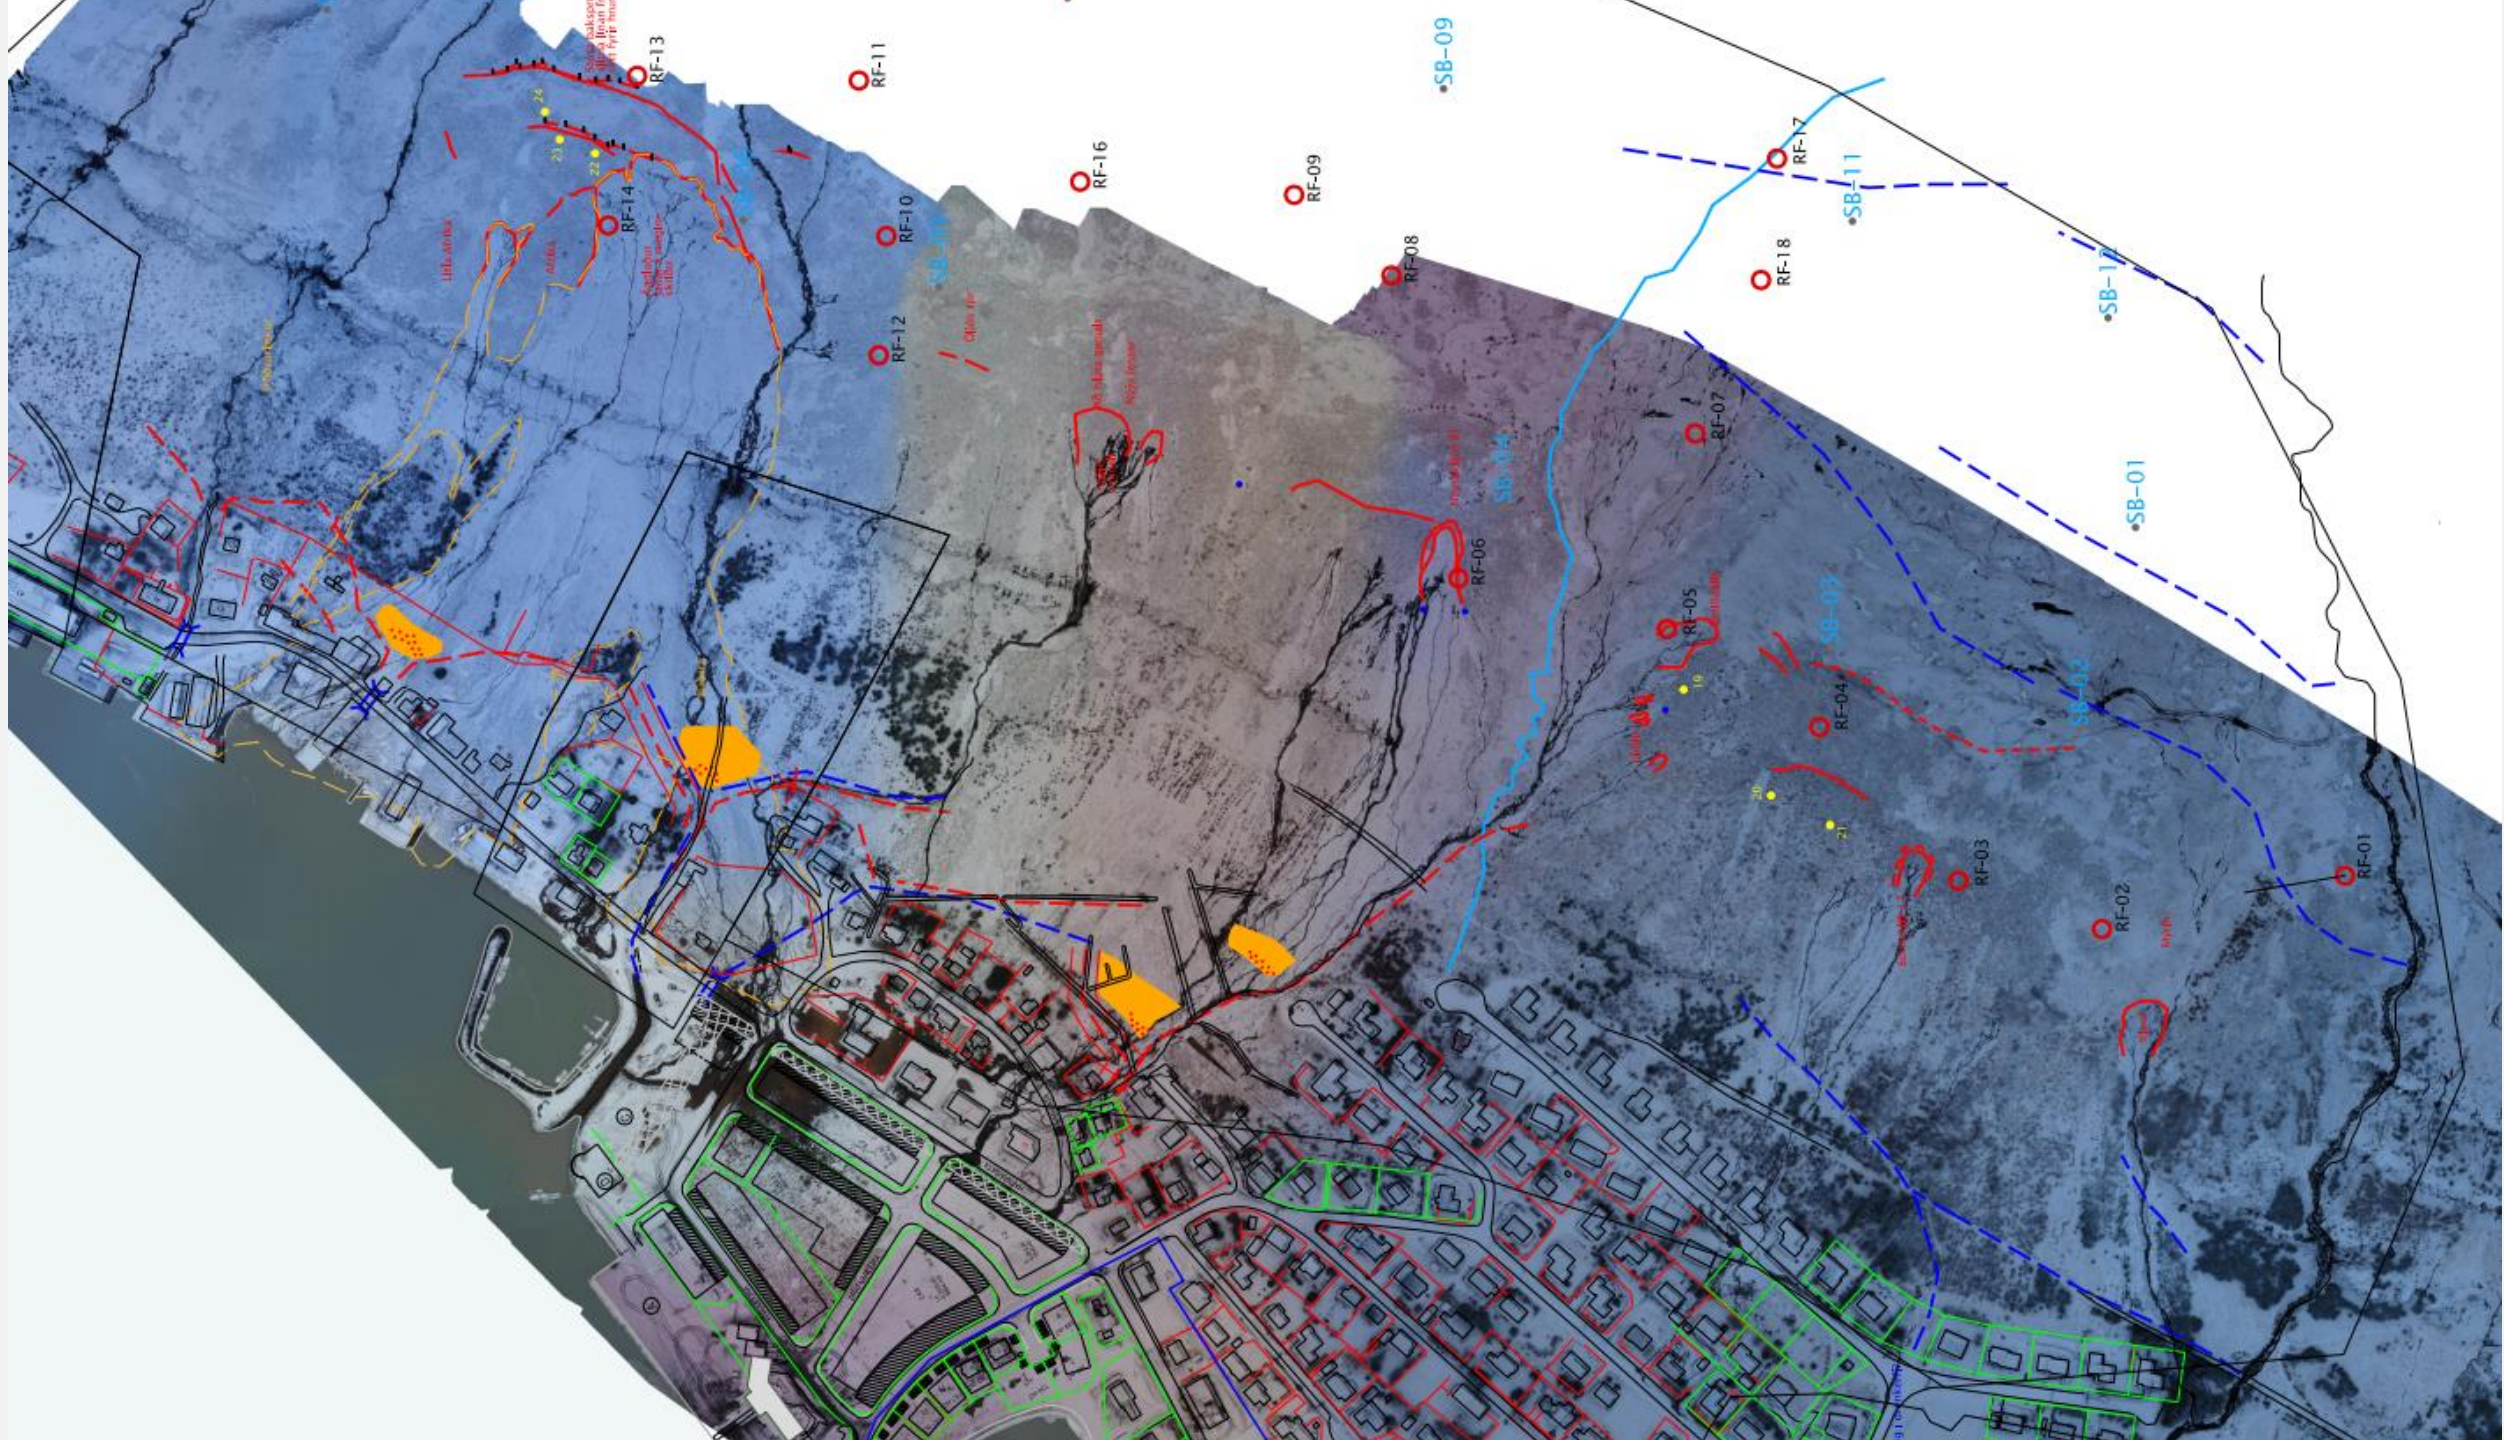
## Botnar - Bráðavarnir

- Botnahlíð:
  - Skurður og varnargarðar ofan byggðar um 400 m, virk hæð um 2 – 2,5 m, léttir líka á grunnvatnsrennsli
- Nautaklauf – Svabbatún:
  - Hreinsa farveg og hækka upp kant frá Baugsvegi og upp fyrir Botnahlíð + tengja veituskurð að Fossvegi, ný veitupverun á Hafnargötu
- Austuvegur - Fossgata:
  - Veituskurður frá Nautaklauf dýpkaður og farvegur og varnargarður frá „Nýju fossum“ rýmkaður og virk hæð aukin
- Búðará:
  - Varnargarðar og veituskurður til suðurs að Fossgötu, farvegur opnaður og hlaðinn upp kantur til norðurs um 5 m en lækkar ofar. Hreinsa og víkka setþró
- Slippurinn:
  - Varnargarðar og veituskurðir + setþró. Ný veitupverun á Hafnargötu
